**Carnarvon One Mile Jetty
Assessment of Remaining Jetty**

And Pile Testing

31 August 2022

Report 0801/2022

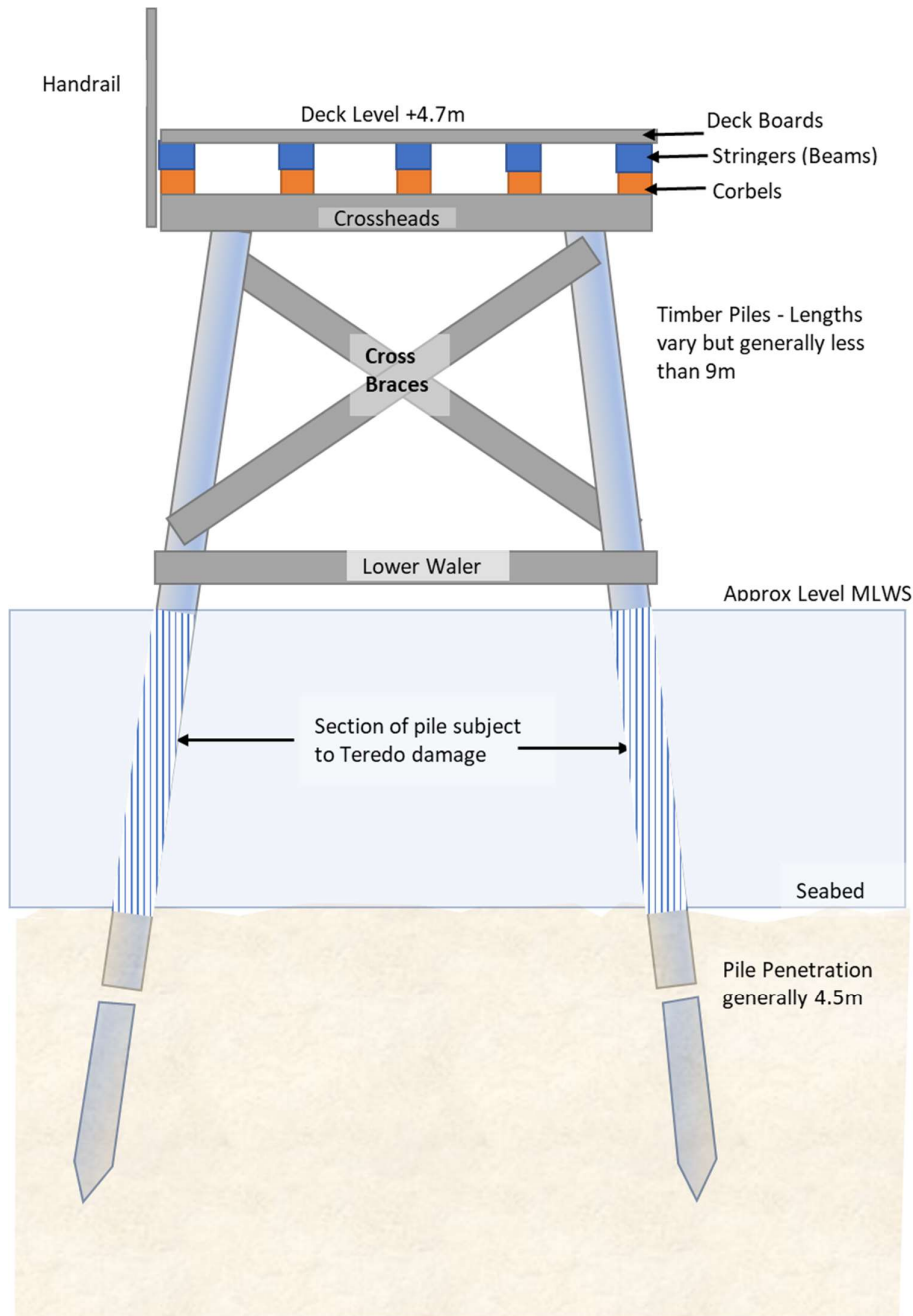
While the exposed section of pile in this area is generally sound there is a high likelihood that the buried section of pile between the existing natural surface and the original seabed has been affected by marine organisms including Teredo. Teredo require the presence of both water and oxygen hence only that portion of the pile in the water column will be affected. The braced portal design means that the maximum pile stress will occur just below lower water level i.e., in the area likely impacted by rot and teredo prior to siltation.

Figure 1: Typical Pier Arrangement - Jetty Approach – prior to silting highlighting areas subject to damage by marine borers

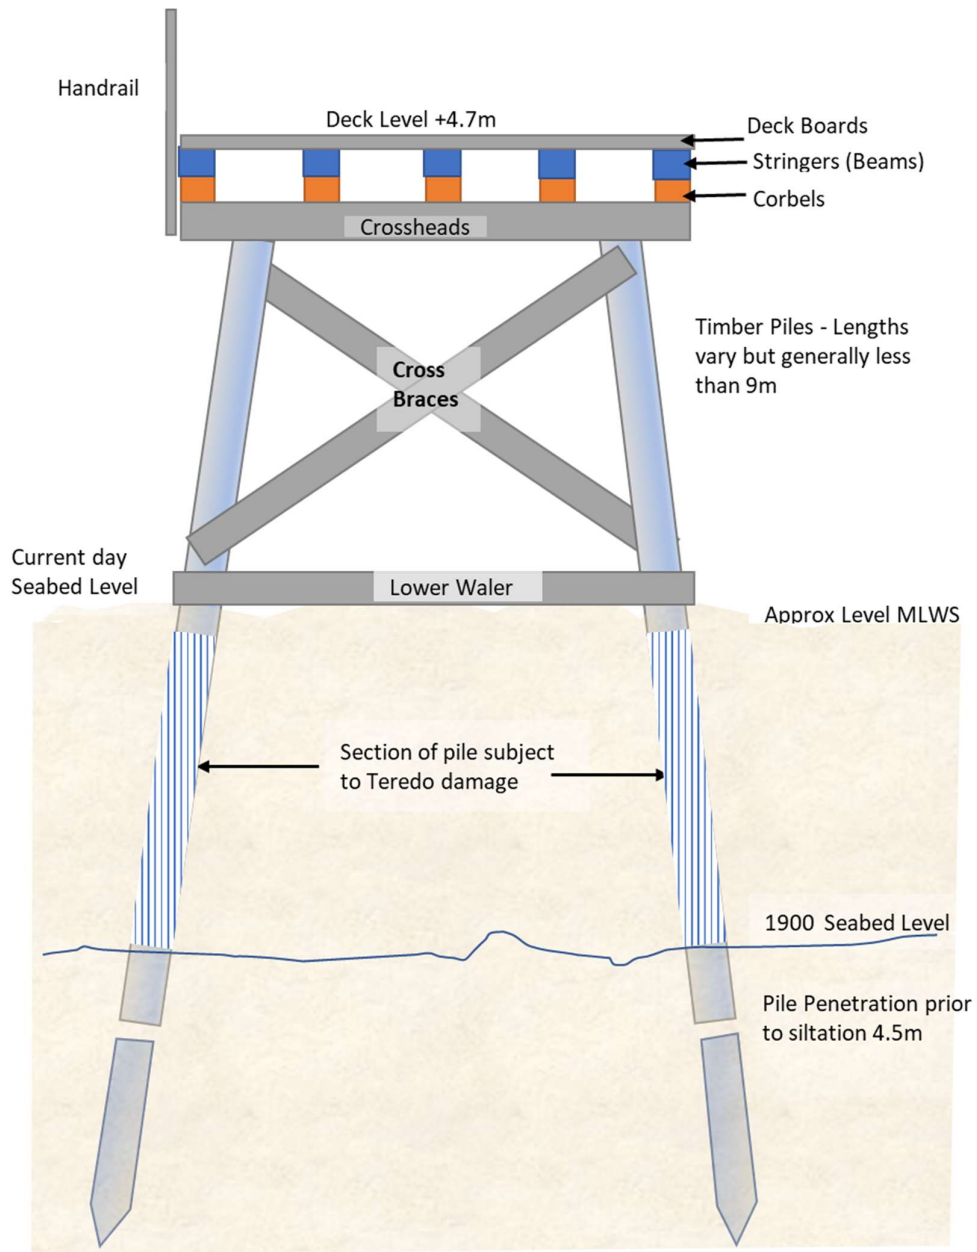
The first 400m of jetty (Pier 1 to Pier 70) is heavily silted and surrounded by mangroves. Anecdotal evidence suggests that the water depth near the jetty abutment was historically deep enough to allow swimming and jumping into the water from the jetty deck. Closure of the south arm of the Gascoyne River and the growth of mangroves may have contributed to the silting of the first 400m to the point where the area is dry except during high tides. Consequently, the jetty in this section is as shown schematically in Figure 2 and Photo 1 and Photo 2.

Figure 2: Cross Section Piers 1 to 70 following siltation.

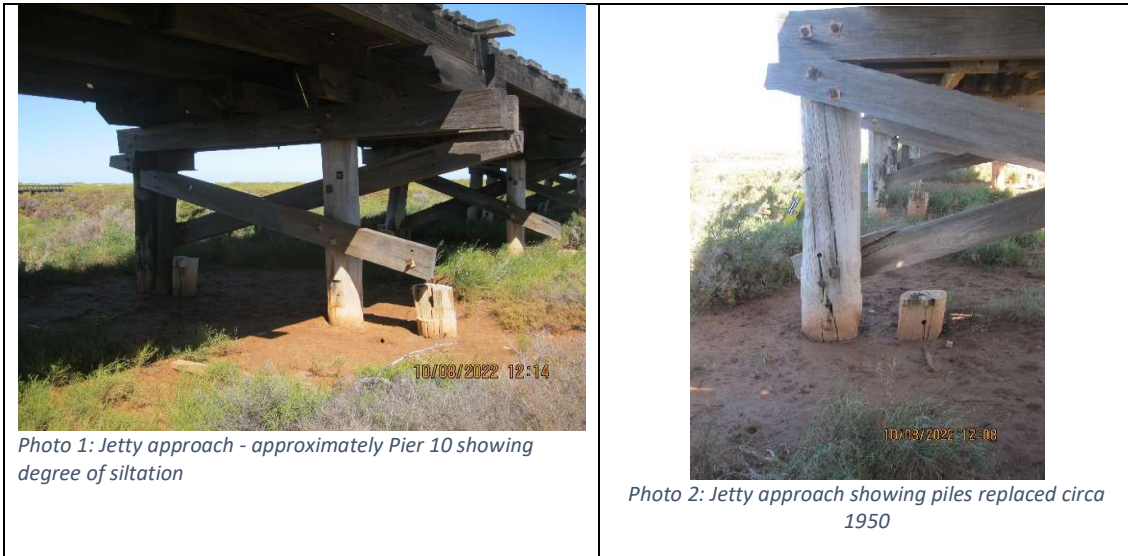
The above photos show that many of the jetty piles were replaced during its lifetime. Markings on the piles show that some of these piles were replaced in the 1950's. This is confirmed by reviewing archived Drawings PWD.WA 25272. The presence of the pile stump would suggest that the pile was cut off just above water level after the replacement pile was installed. Examination of the bolt holes in the crosshead also suggests that crossheads were also replaced in some instances.

A review of historical records (PWD.WA 25272-01-01) shows that 50% of the piles between Piers 1 and 70 were replaced or repaired by splicing between 1920 and 1961 . This percentage is higher for the offshore section. The reason for replacement of piles in this zone is most likely due to marine borer attack, rotting or split piles. As previously mentioned, this is commensurate with the expected life of a timber pile in the marine environment when marine borers are present.

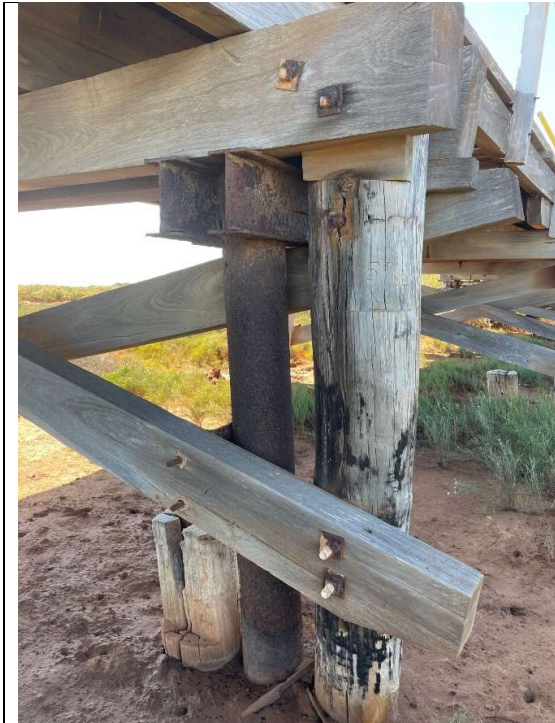
The pile replacement/repair plans state that pile treatment for the replacement piles was “charred and tarred”. The efficacy or life of this type of treatment is not known, particularly in relation to deterring marine borers, however it is likely that any treatment within the water column would be washed away over a period of time. The remnants of the charring and tarring process can be seen on the black staining on the piles in the photos below.

Photo 3: Pile replaced circa 1950 showing remnant black pile "charred and tarred" treatment

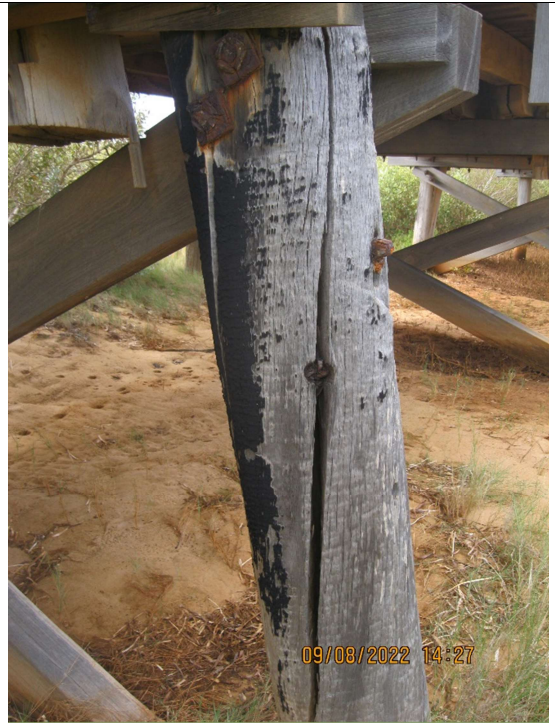
Photo 4: Pile replaced circa 1950 showing remnant black pile treatment. Remains of original pile still attached to crosshead.

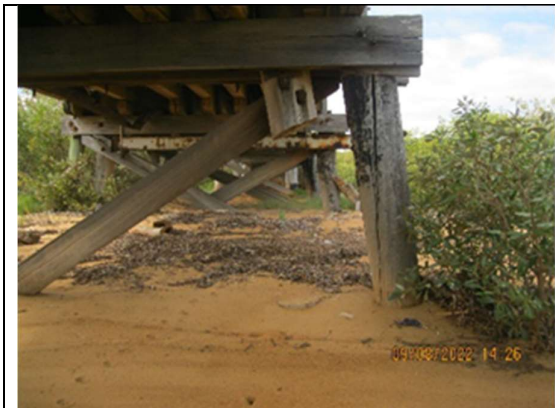
Photo 6: Replaced pile showing black remnants of pile treatment

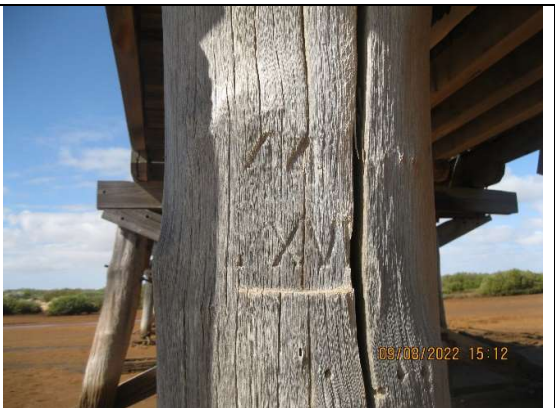
Photo 7: Replaced pile showing markings - 44 indicates year of replacement (1944) and roman numerals XXVI indicates length of pile at 26 feet.

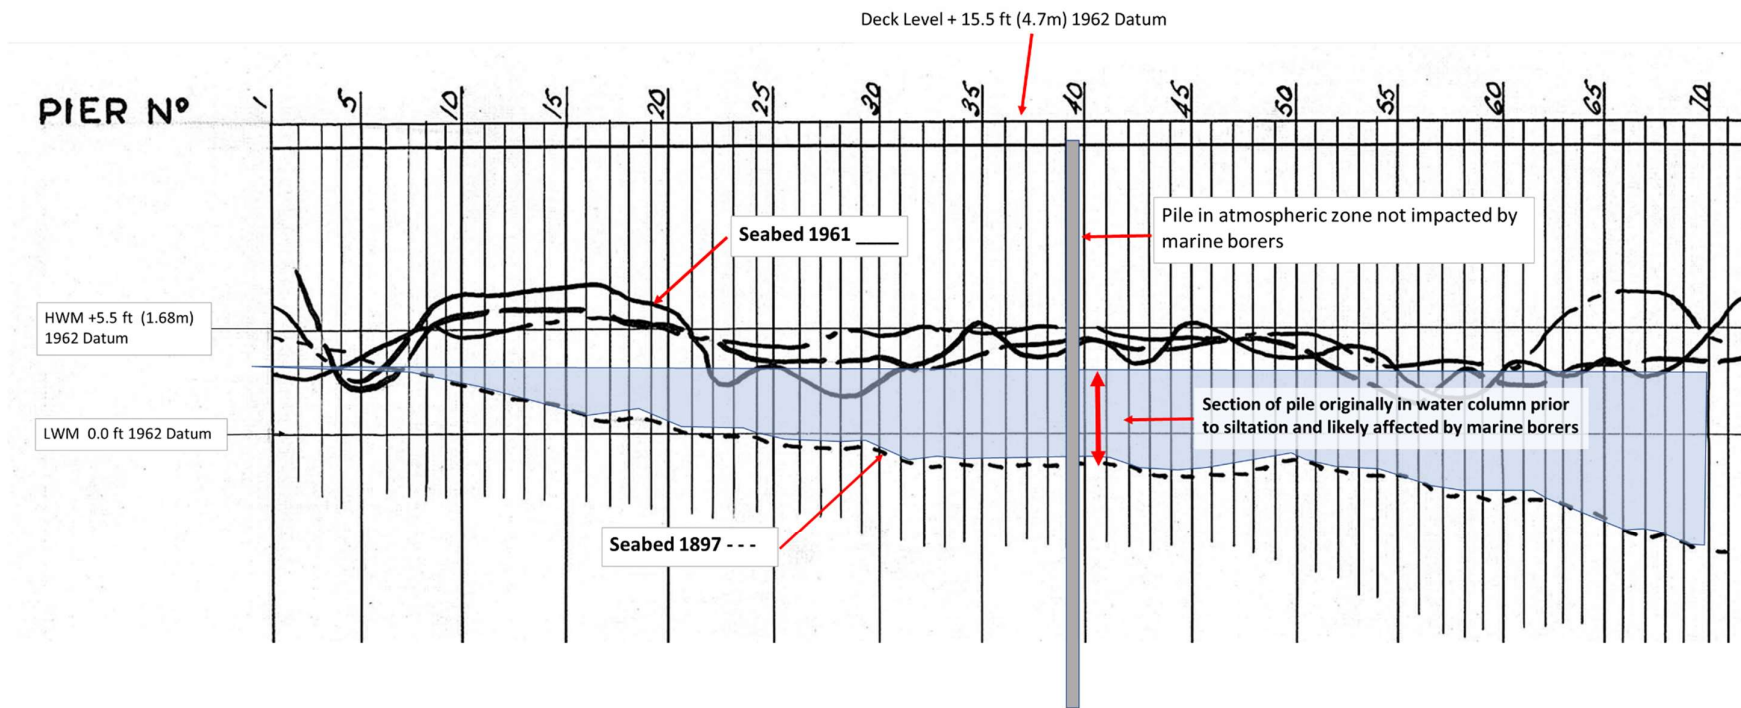
Figure 3: Comparison of seabed profiles between 1897 and 1961 between Piers 1 to 70 showing level of siltation and likely areas of marine borer infestation prior to siltation.

Comparison of the 1897 survey and the 1961 survey (Ref PWD.WA 38794-1-1) shows that siltation between Piers 1 and 70 varies between almost zero at the abutment and 2.6m at Pier 70. It is likely that siltation has continued since the 1961 survey due to the growth of mangroves.

It is highly probable that piles in this location have been impacted by marine borers in the section previously inundated with water.

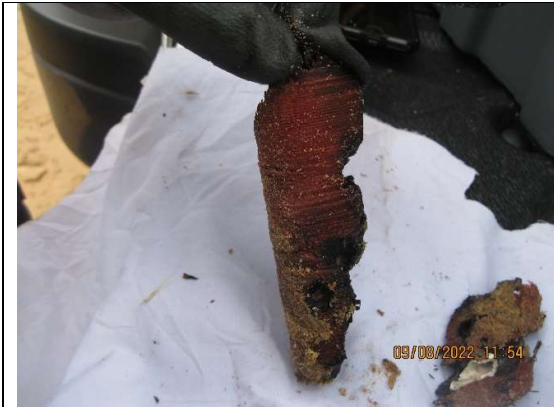
Evidence of Teredo was found in the cored piles in the beach area however there was little evidence of marine borers in the Piers within the mangrove area near the abutment. This is likely because the coring did not intercept the historic zone likely affected by marine borers when there was no siltation, i.e., that portion of pile that was previously in the water column as shown in Figure 3. As previously stated, marine borers require both oxygen and water to thrive.

Photo 9: Limited core extracted from Pier 110 showing evidence of marine borers

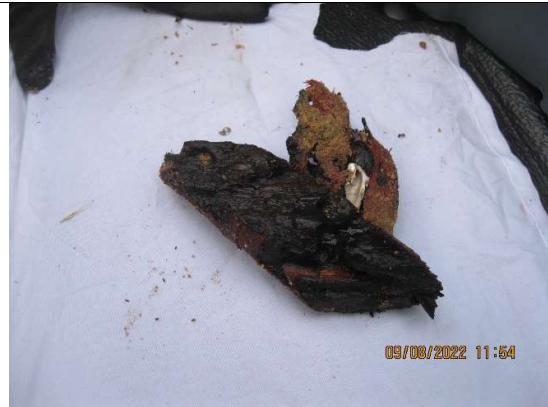
Photo 10: Core from Pier 10. White head of dead Teredo can be seen in the cavity created by the borer

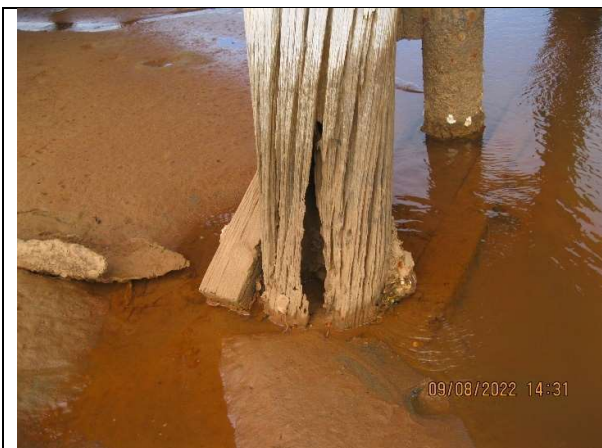
Access to some areas in the intertidal area between bents 70 and 100 was difficult due to the soft ground conditions. Photos below show that many piles in this area are in poor condition and therefore have little or no structural capacity.

Photo 11: Split and rotted pile in intertidal zone - replacement steel pile alongside is corroded.

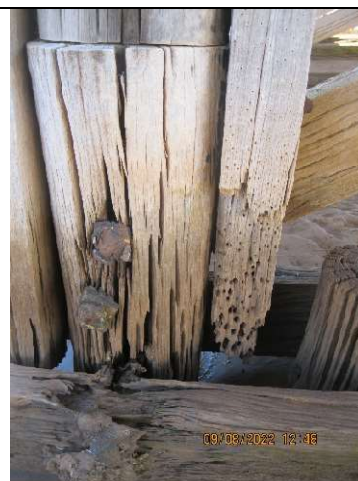
Photo 12: Split original pile which has been spliced with new upper section. Splicing supports either side showing evidence of marine borers.

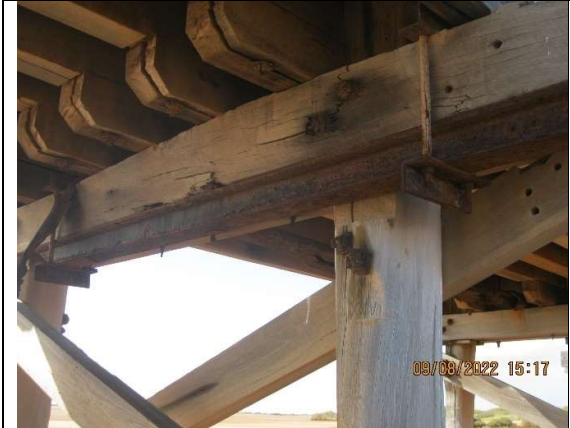
Some split or cracked crossheads have been strengthened by underslung steel structural member as shown in Photo 13 and Photo 14. Replacing a crosshead in the mangrove area can be problematic due to access constraints.

Photo 13: Cracked crosshead strengthened by underslung steel member

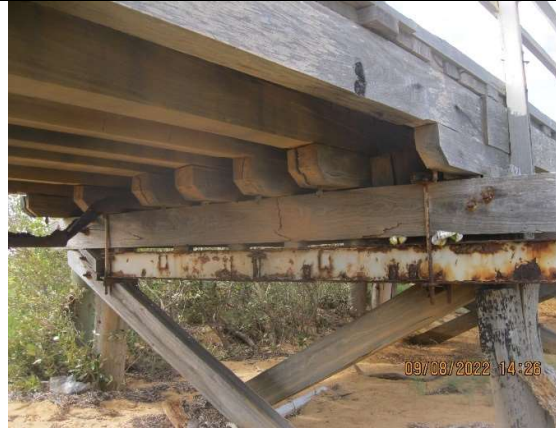
Photo 14: Cracked crosshead strengthened by underslung steel member

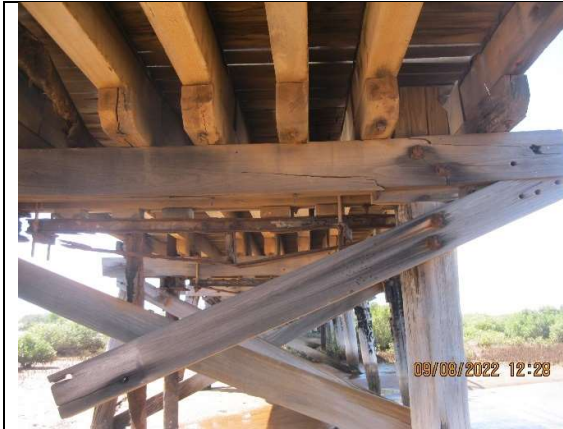
Photo 15: Incomplete cross bracing and cracked crosshead

Given the likelihood of Teredo infestation for the pile section originally or currently within the water column which reduces the pile capacity, cross bracing is vitally important to maintain any structural integrity. If any of the jetty is to be maintained, then the cross bracing must be replaced or reconnected as appropriate.

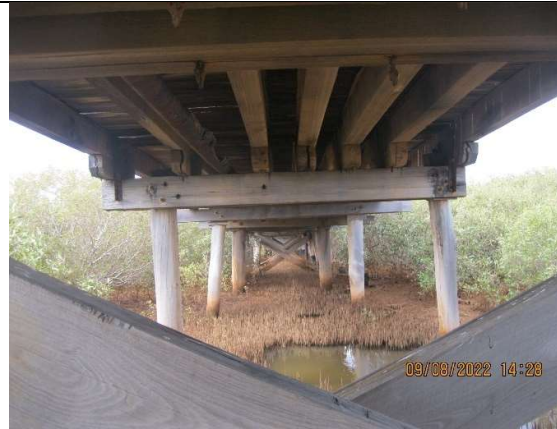
Photo 16: No cross bracing in 3 consecutive bays

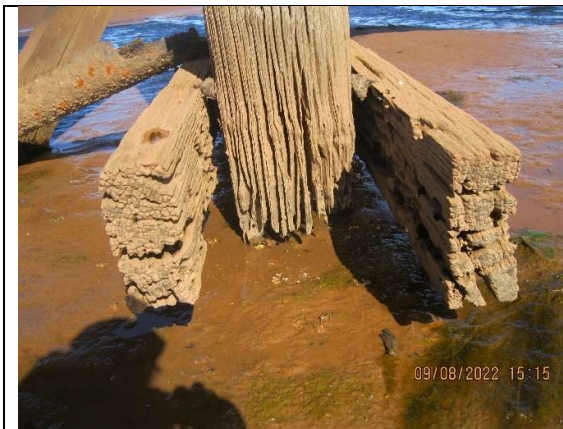
Photo 17: Rotted lower waler and pile

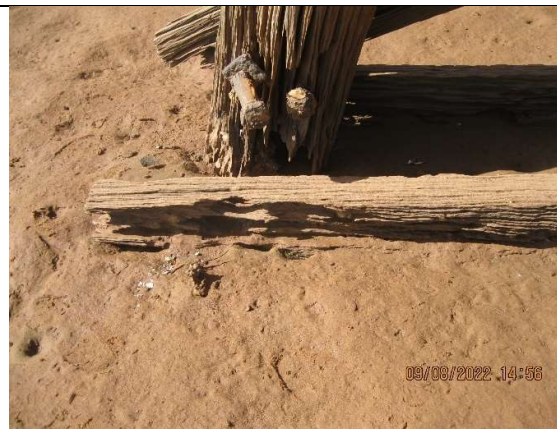
Photo 18: Disconnected lower waler

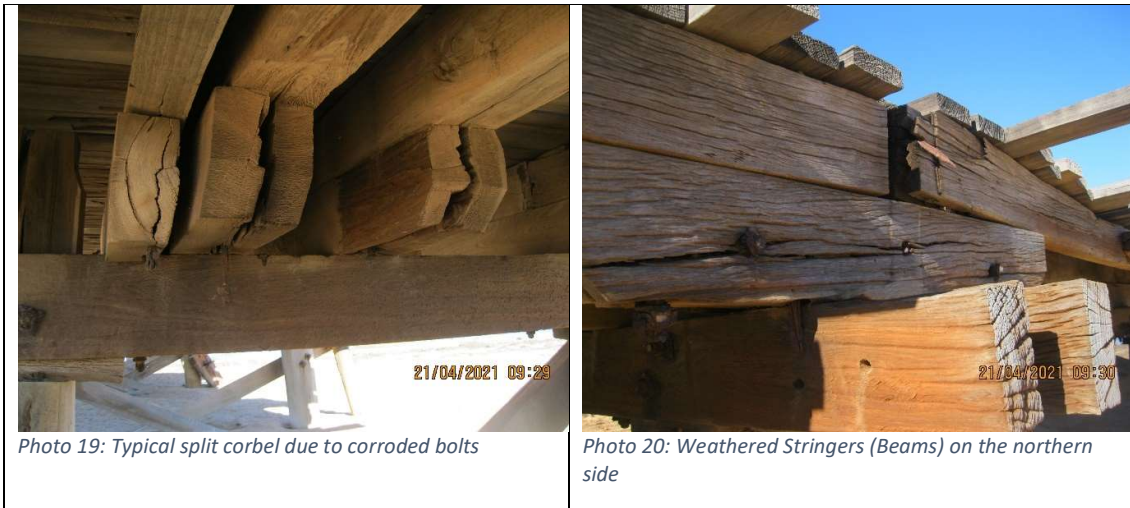
Most of the stringers are in good condition except for the stringers on the northern face which are heavily weathered. Many Stringers (beams) and corbels were replaced or supplemented with additional beams in the 1950's. The need for the replacement is not known however at that time jetty deck loading would have been higher than that required for pedestrian purposes.

Photo 19: Typical split corbel due to corroded bolts

Photo 20: Weathered Stringers (Beams) on the northern side

Most of the corbels which support the stringers are split due to the corrosion of the bolts securing the stringers to the corbels. It would be a difficult task to replace a corbel as it would likely require the removal of a portion of the deck and the installation of temporary supports under the stringers. This would be considered necessary in any area subject to uplift from cyclonic waves. As this is unlikely to occur in the region of the abutment (Piers 1 to 60) an alternative strategy may be the removal of the corroded bolt and inserting cross bolts through the corbel to clamp the split before renewing the bolt securing the stringer to the corbel.

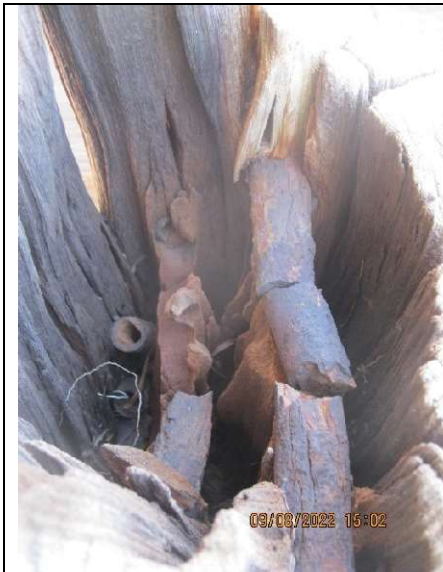
The degree of corrosion to the bolts varies and, in many cases, the corroded bolts expand and cause the timber to split – particularly in relation to the crossheads. Various reconstruction plans state that bolts should be either cadmium plated, coated with lanolin, or wrought iron. Drawing PWD.WA 26741 dealing with the reconstruction of the Jetty head stated that all bolts below MHW should be Muntz Metal (also known as yellow metal) which is an alpha-beta brass alloy composed of approximately 60% copper, 40% zinc and a trace of iron. A corroded bolt taken from the lower section of a replaced pile exhibited unusual corrosion whereby the bolt corroded internally and left a hollow outer casing as shown in Photo 22.

Photo 21: Corroded bolts inside a rotted cut off pile

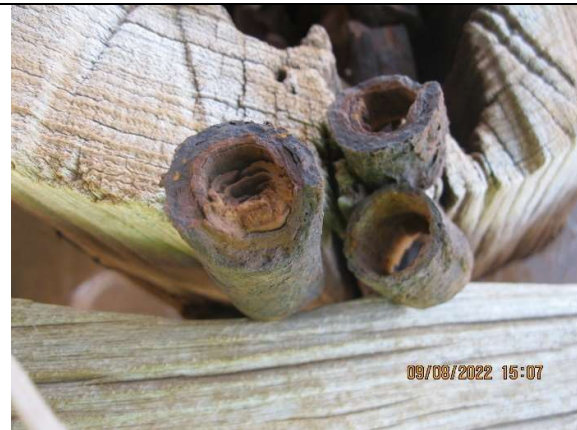
Photo 22: Unusual corrosion mechanism of bolt

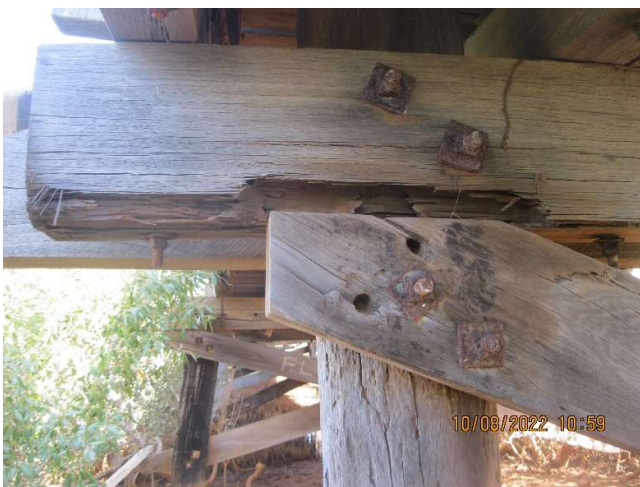
Although there is evidence of termite activity it does not seem to be active, and damage is minimal.

Photo 23: Termite damage to crosshead

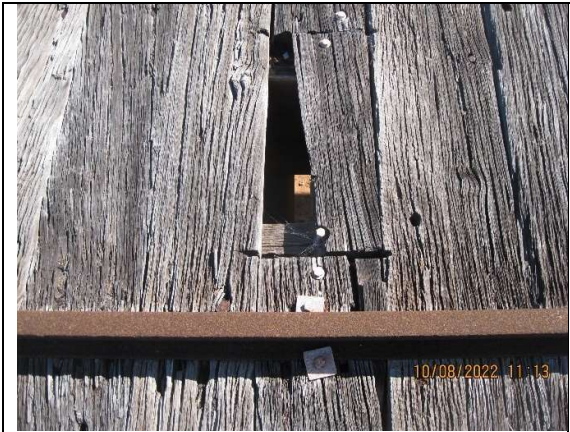
Photo 24: Split and weathered deck boards

Deck planks are badly weathered or broken. The uneven surface presents a continuous trip hazard, particularly for the disabled. Should a section of the jetty be retained then the entire decking in that section should be replaced. The practice of placing a concrete topping on the existing deck planks is not recommended in this instance as this would remove the ability to replace piling by driving a steel pile between the crossheads should pile replacement be necessary.

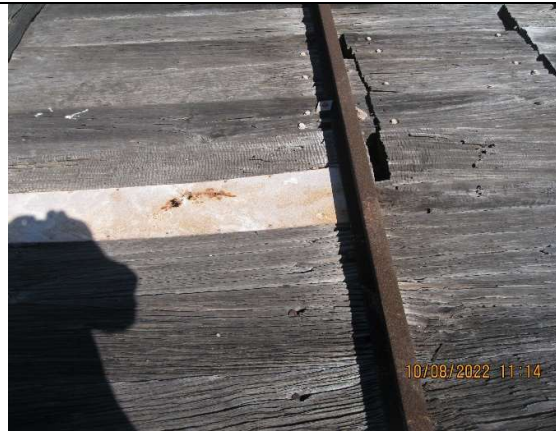
Photo 25: Weathered deck boards

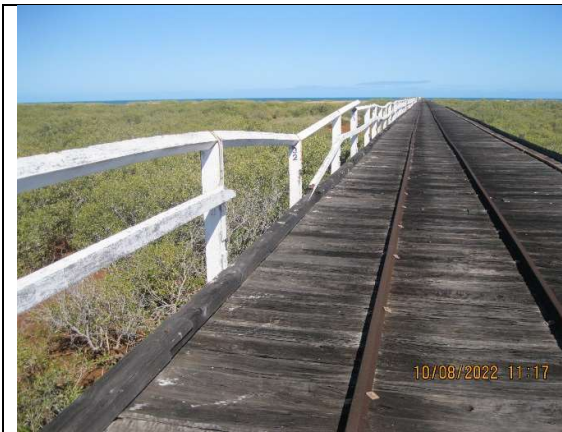
The handrailing (southern side only) is in various states of repair. The remaining timber is generally sound however fastenings should be replaced.

Photo 26: Broken handrailing

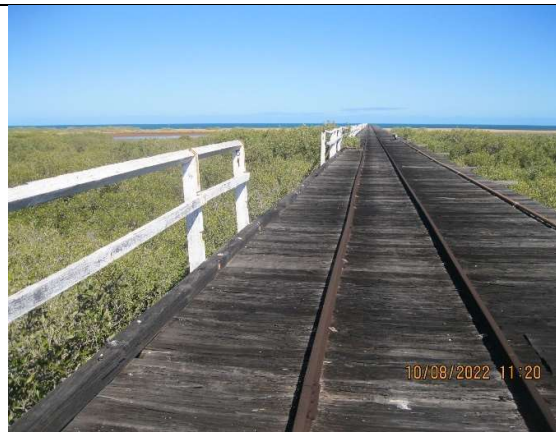
Photo 27: Missing handrailing
