**Carnarvon One Mile Jetty
Assessment of Remaining Jetty**

And Pile Testing

31 August 2022

Report 0801/2022

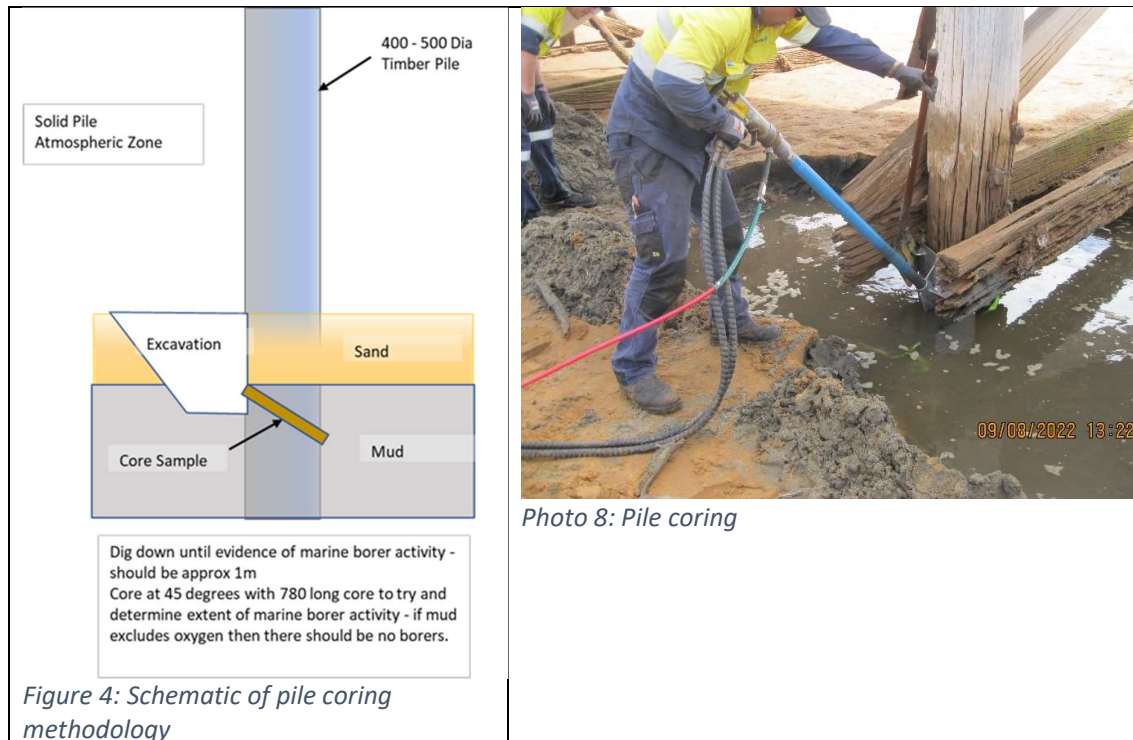
A schematic of the methodology is shown in Figure 4. Photo 8 shows the coring operation. Cored holes were plugged with a 50mm wooden dowel.

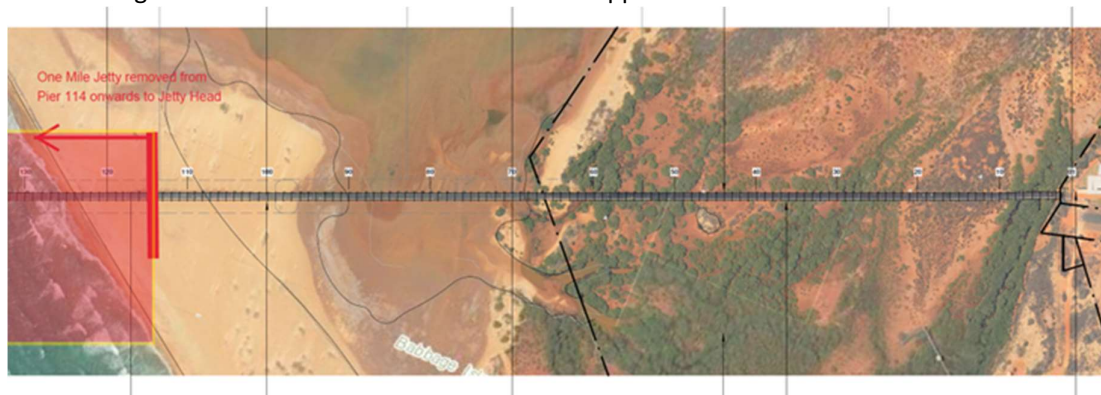
Figure 5: Jetty showing Pier Numbers - Pier 1 is at the abutment - Pier 114 is the extent of the remaining jetty

A random selection of piles at the western beach end, the intertidal zone and near the abutment were cored. These were at Piers 3, 8, 11, 74, 76, 77, 86, 109, 110 and 113. The location of Piers is shown in Figure 5. Photos of the cores are shown in Appendix A.

Since the time of deconstruction of the jetty, the beach at the western end had eroded such that Piers 109 to 114 were now in the water.
